Metallosis and Metal-Induced Synovitis Following Total Knee Arthroplasty: Review of Radiographic and CT Findings

Radiology Case. 2010 Sep; 4(9):7-17 :: DOI: 10.3941/jrcr.v4i9.423

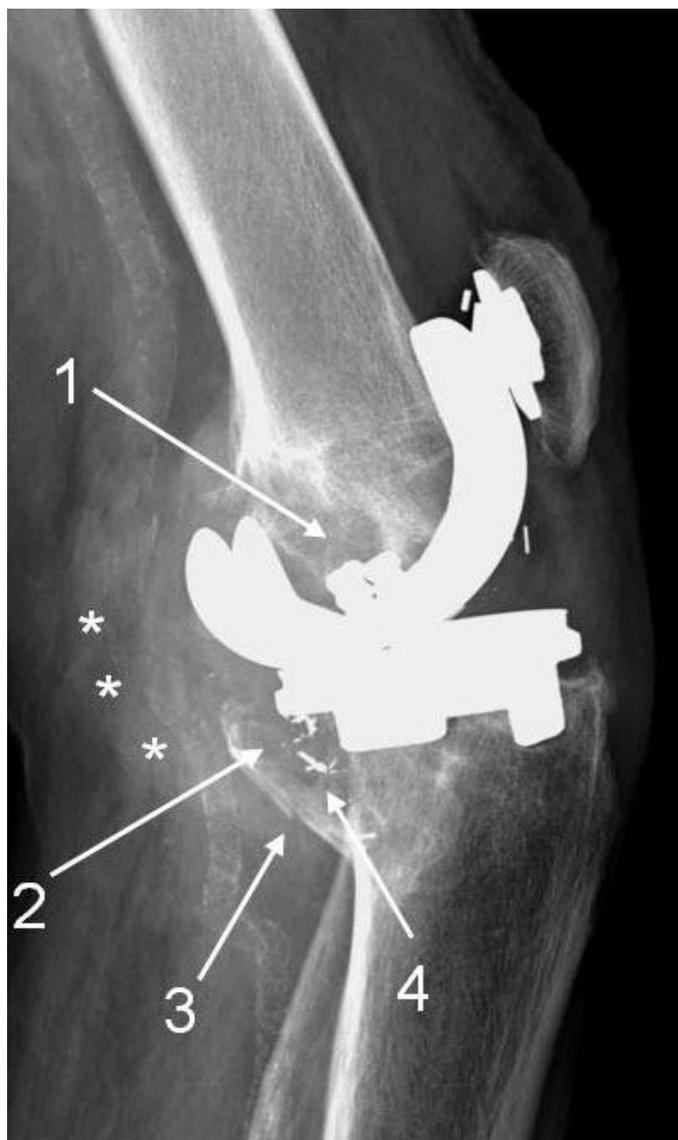
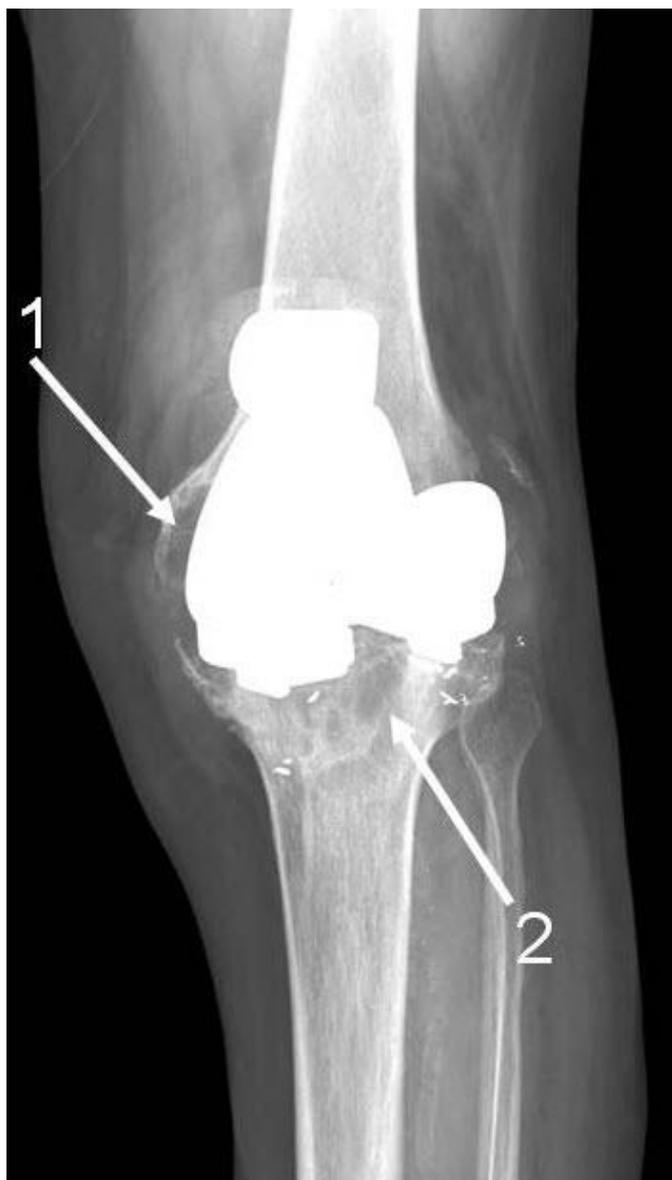
Fig. 1a

This nicely demonstrated the lytic areas in close proximity to the tibial component, and their internal characteristics (Fig. 2). Scattered metallic debris fragments were also present (Figs. 1 and 2). The patient went on to undergo a TKA revision. Because the patellar component showed minimal wear of the polyethylene surface intra-operatively, it was not replaced at that time. Despite the lack of wear on the patellar component, significant metal-on-metal wear of the tibial and femoral components and periprosthetic metallic debris was found. The revision was performed using implants from a Legion Revision Knee System (Smith and Nephew Inc., Memphis, TN). Specifically, a Legion Oxinium constrained femoral component with a straight cemented stem, a Legion Oxinium revision tibial base plate with a cemented stem, and a constrained Genesis II articular polyethylene insert were used. Oxinium is a trademark of Smith and Nephew and consists of oxidized zirconium, without detectable nickel elements. Histologic examination of the periprosthetic tissues

Figure 1: 74 year-old man with prior left total knee arthroplasty and patellar revision with increasing pain, now with periprosthetic osteolysis and manifestations of metallosis. Lateral (Fig. 1a) and AP (Fig. 1b) radiographs of the left knee show areas of osteolysis (arrows #1 and #2 in both projections) with associated fracturing of the tibial plateau (arrow #3, lateral view). Several metallic debris fragments are evident (arrow #4, lateral view). Amorphous increased density is present posterior to the knee on the lateral view (*). Similar findings seen at the hip have been referred to as the "cloud sign" of metallosis. A joint effusion is present. Vascular calcifications are noted.

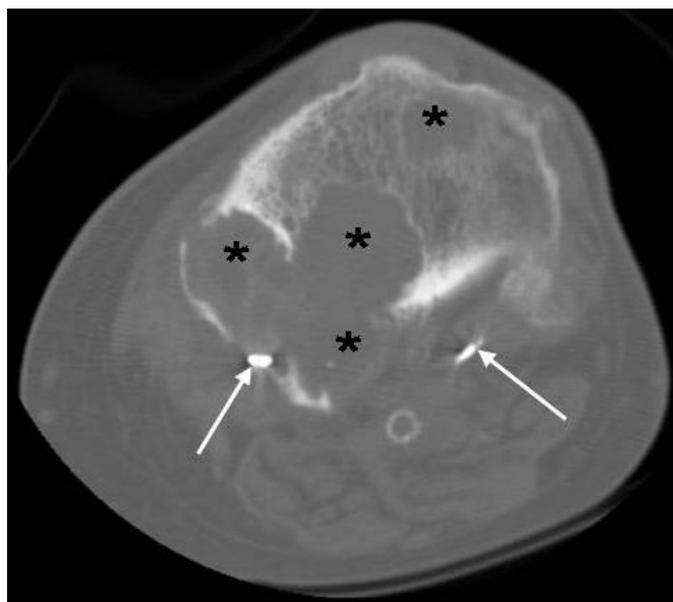
Figure 2: 74 year-old man with prior left total knee arthroplasty and periprosthetic osteolysis. Noncontrast axial CT of the left lower extremity at the level of the proximal tibia with bone algorithm (Fig. 2a) and soft tissue algorithm (Fig. 2b). (GE Lightspeed 16 CT scanner; kVp 120; mA 80; slice thickness 2.5 mm).

Fig. 2a shows several rounded lucencies (*) in the proximal tibia consistent with osteolysis. The differential diagnosis for periprosthetic osteolysis would include small particle disease, infection, and hardware loosening. Note is made of two metallic debris fragments (solid arrows). Atherosclerotic calcifications are also present.

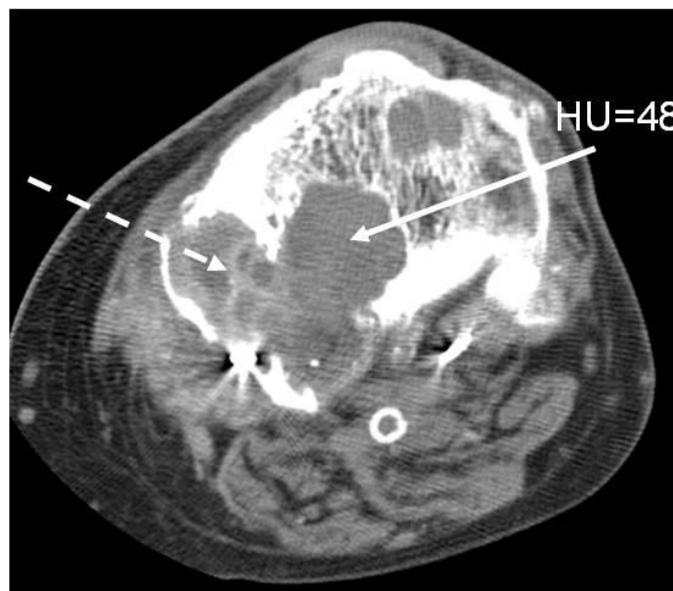
Fig. 2b

Fig 2b (CT image with soft tissue algorithm) better shows the internal characteristics and complexity of the lytic foci. Curvilinear and nearly circular intermediate attenuation structures with central lower attenuation are seen within the more medial lytic lesion (dashed arrow). The Hounsfield units of the largest lytic area measured 48 (solid arrow).

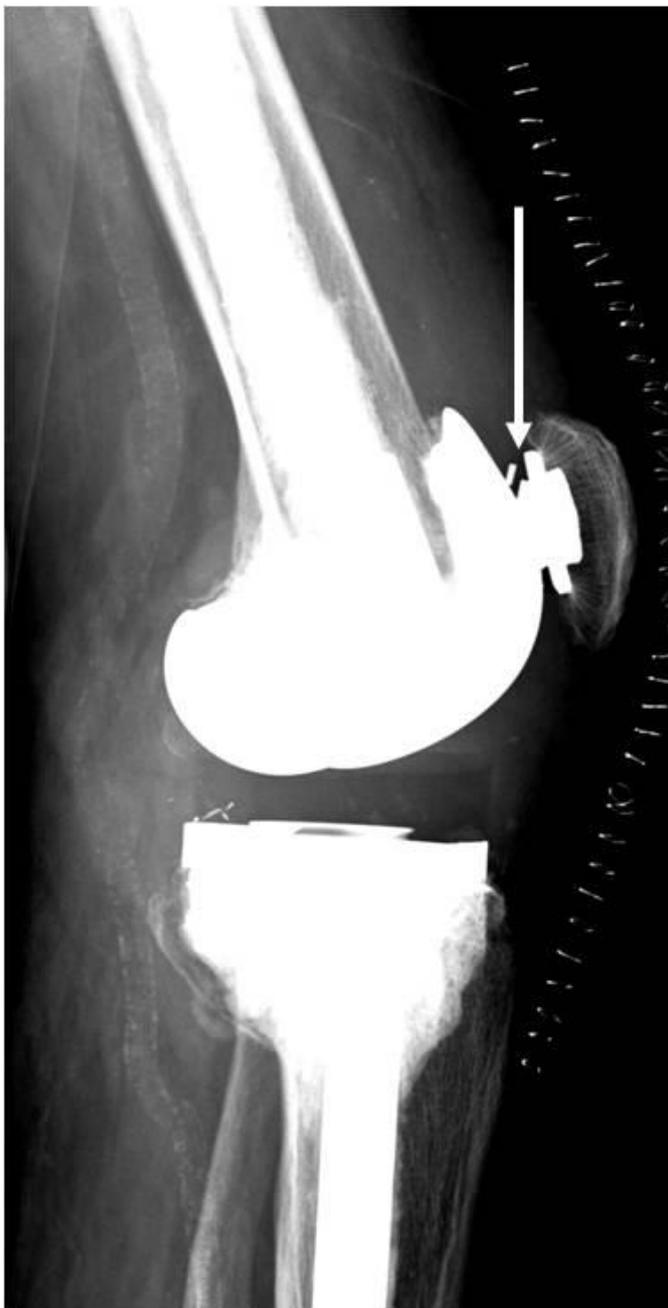
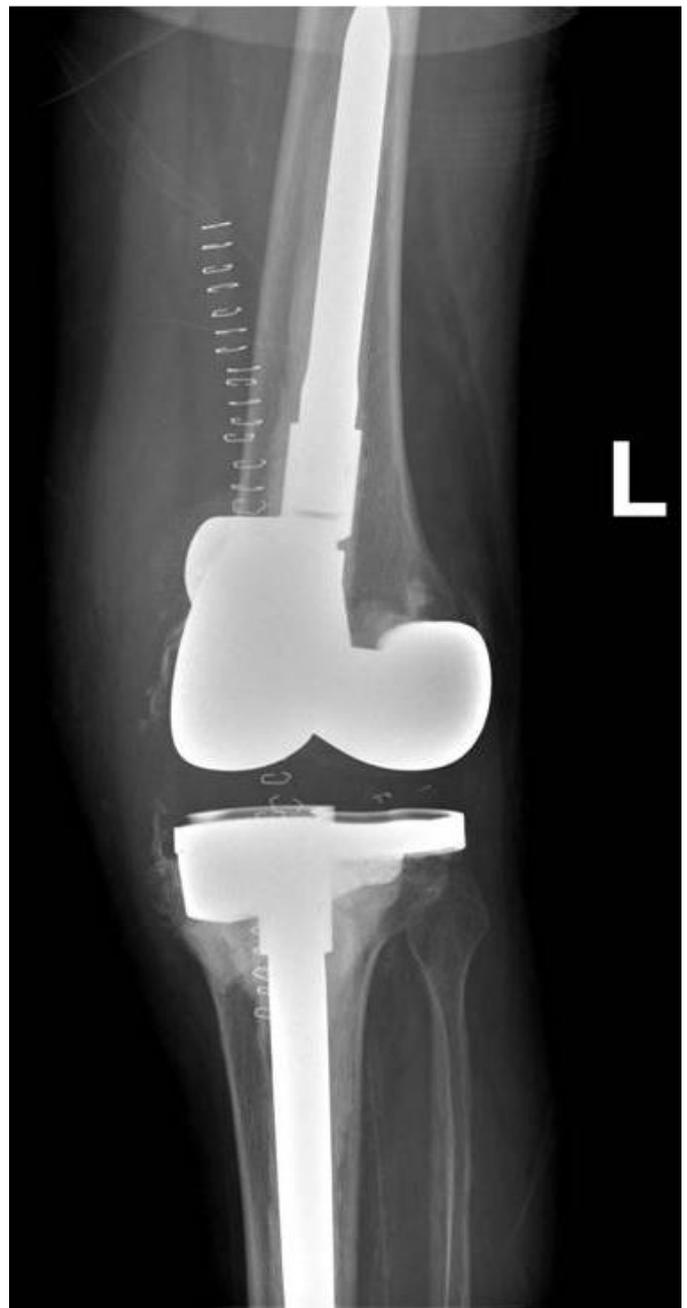
Fig. 3a

Figure 3: 74 year-old man with left total knee arthroplasty hardware failure and metallosis. Lateral (Fig. 3a) and AP (Fig. 3b) radiographs of the left knee were obtained after TKA revision (refer to Figs. 1a and 1b for preoperative radiographs), showing postoperative cutaneous staples. The lateral view demonstrates a small linear metallic density of the patellar polyethylene liner (arrow) in appropriate position. Notice there is now a tibial rod component in place. A joint effusion is also present.

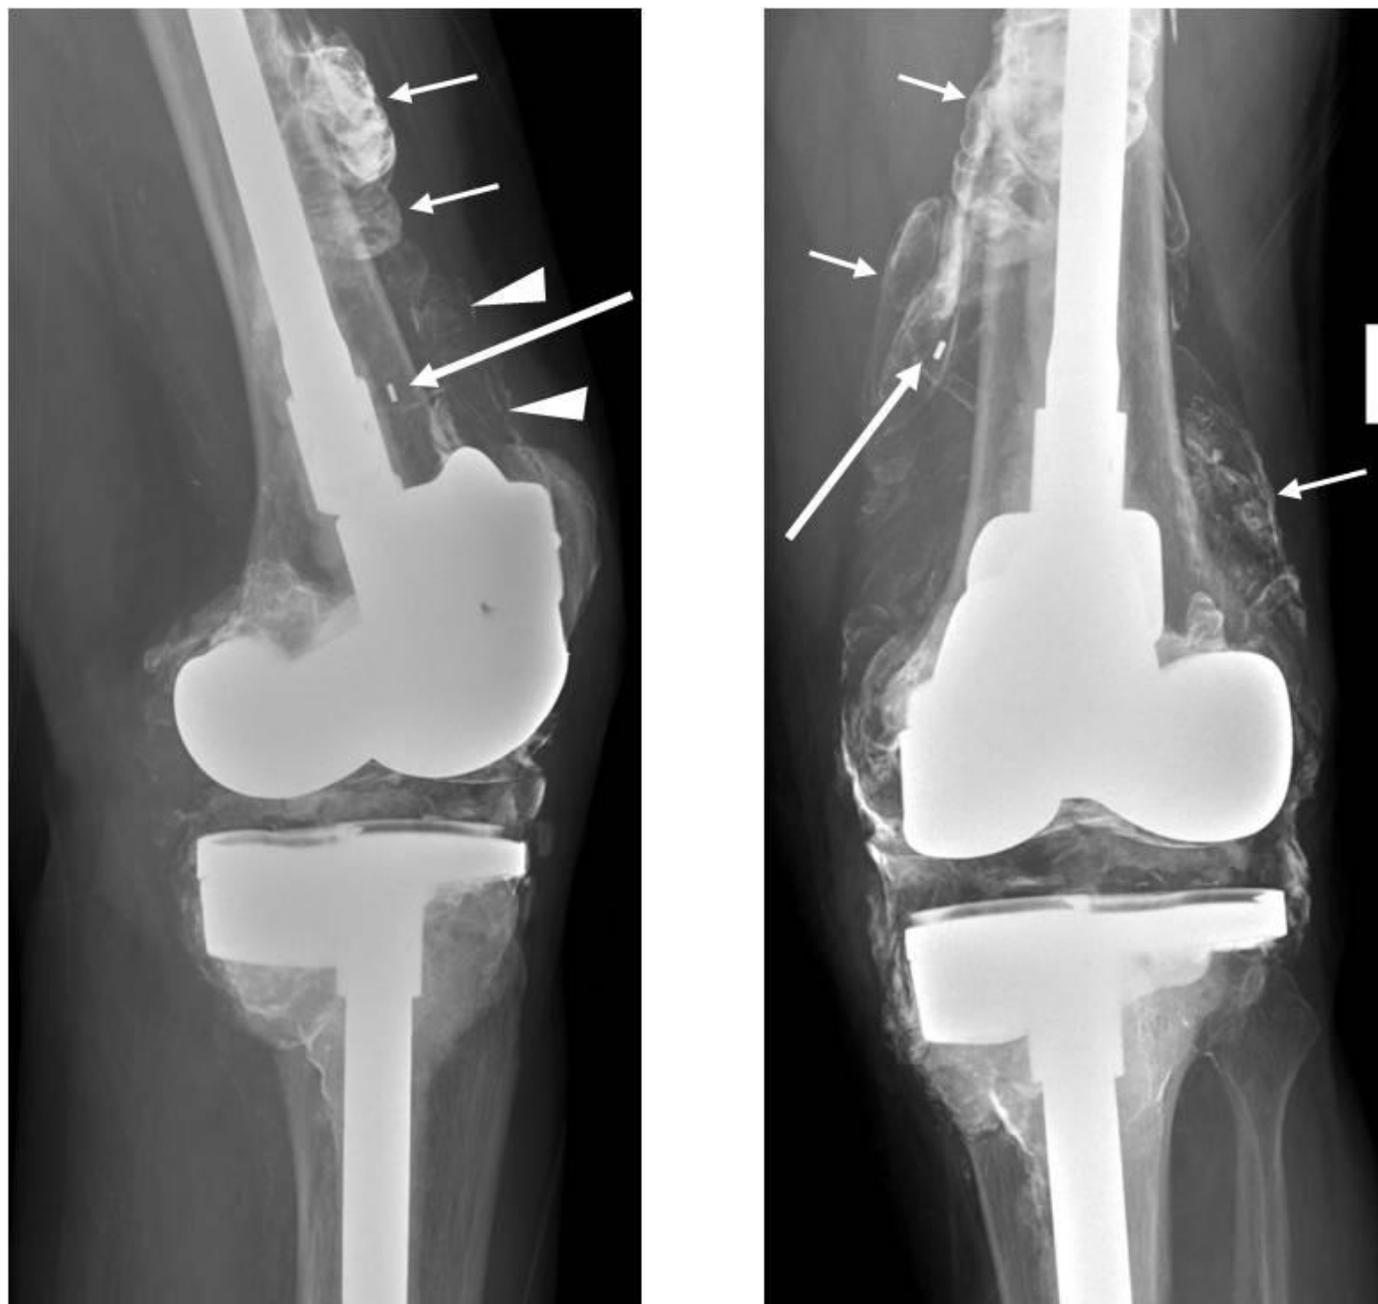
Figure 4a and 4b: These "off lateral (a = left)" and AP (b = right) radiographs of the left knee were obtained about 18 months after the Fig. 3 images. There are new lobulated and somewhat bubbly densities around the distal femur (short white arrows in Figs. 4a and b) similar to the "bubble sign" that has been described after total hip arthroplasty. Linear densities are also seen in the suprapatellar region on the lateral view (arrowheads in Fig. 4a), similar to the "metal-line sign" of metal-induced synovitis. Both the "bubble sign" and "metal-line sign" represent metallic debris outlining the joint space, effectively demonstrating the joint cavity. Also, note that the small metallic density associated with the patellar polyethylene marker has dissociated superomedially (long arrow in Figs. 4a and 4b), compared to Fig. 3. This is an uncommon but important finding of hardware failure.

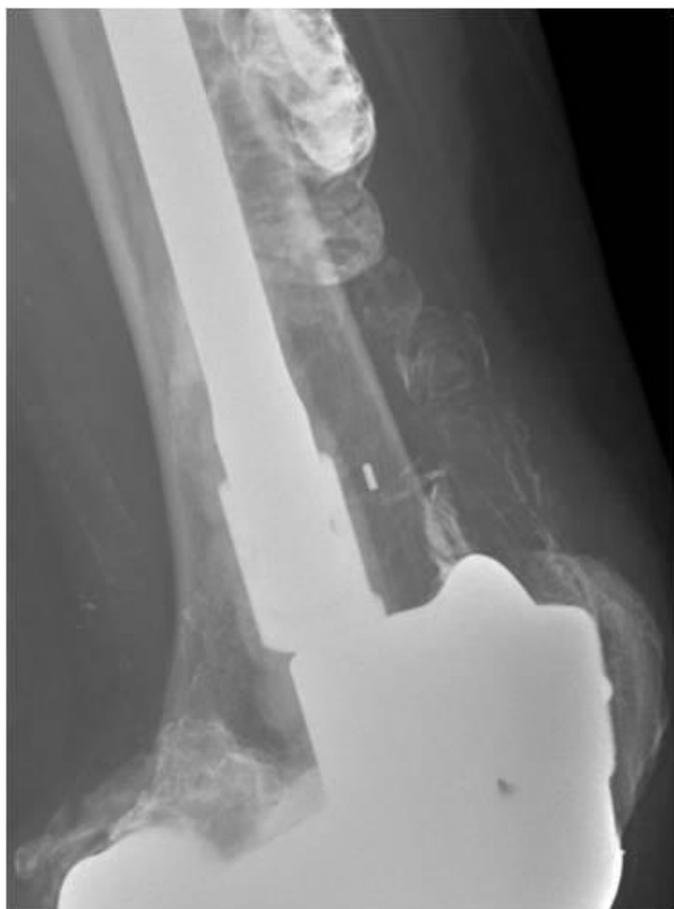
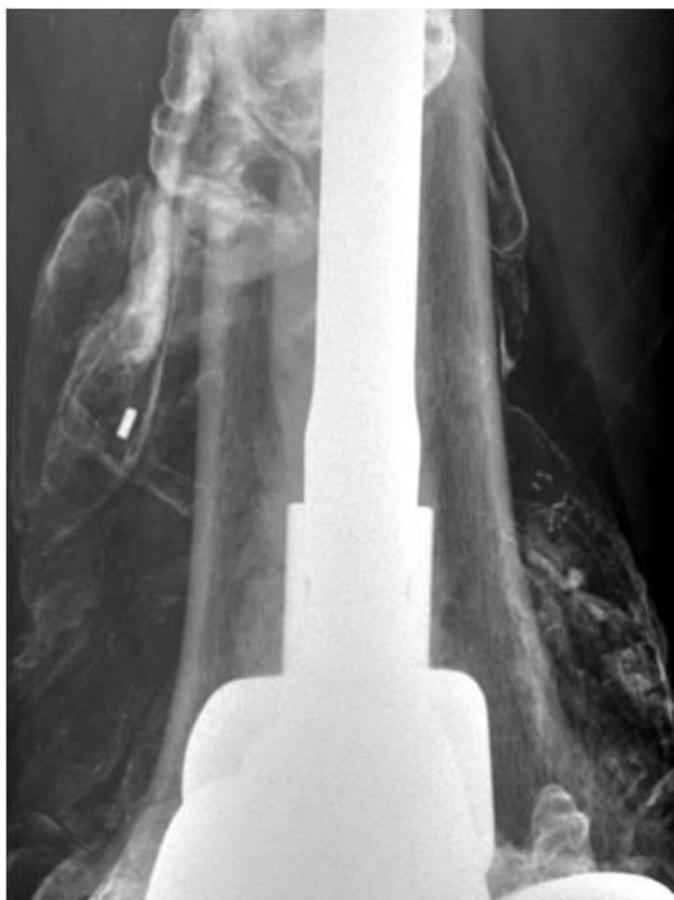
Fig. 4c

Figures 4c and 4d are magnification views of the "off-lateral" and AP views in Figs. 4a and 4b, respectively, better demonstrating the findings.

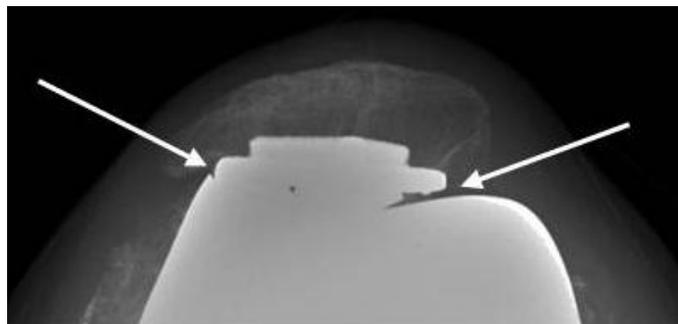
Figure 4e: The sunrise view of the left knee shows close apposition of the metal backing of the patellar component with the trochlear groove of the femoral component (arrows). This finding can be a sign of abnormal position of the polyethylene liner, but the differential for patellofemoral narrowing would also include liner wear and technical factors due to projection.

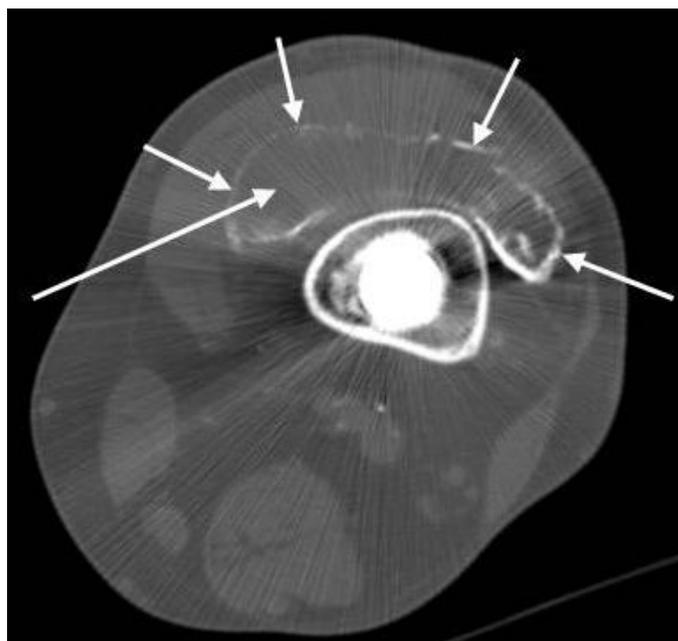
Approximately 18 months after the TKA revision discussed above, the patient developed progressive left knee swelling, crepitus, and pain, greatest near the patella and distal femur. Radiographs of the left knee were obtained for evaluation, and demonstrated new bubbly and curvilinear radio-densities around the knee, most evident adjacent to the distal femur, particularly in the suprapatellar pouch region (Figs. 4a-d). Additionally, a small linear metallic density had migrated away from the patella, thought to represent a dissociated patellar polyethylene liner (Figs. 4a-d). Close apposition of the patellar and anterior femoral components was present on the sunrise view radiograph (Fig. 4e), also suspicious for patellar liner wear and dissociation. A CT was ordered to evaluate the left knee and to better delineate the joint space. This confirmed extensive linear densities outlining a distended joint capsule (Fig. 5).

Figure 5: 74 year-old man after left total knee arthroplasty revision with metallosis and metal-induced synovitis. Noncontrast axial CT of the left lower extremity at the level of the distal femur (GE Lightspeed 16 CT scanner; kVp 120; mA 310; 2.5 mm slice thickness) demonstrates linear radiodensities outlining the suprapatellar joint space (short arrows). The joint cavity is distended and outlined by increased density. This finding corresponds with the "metal-line sign" seen on plain radiographs (see Fig. 4a), consistent with metal-induced synovitis. There is relatively low attenuation within the joint space. The Hounsfield unit measurement in this region is limited by streak artifact from the adjacent hardware, but the area that the long arrow points to in this image measured 100 Hounsfield units.

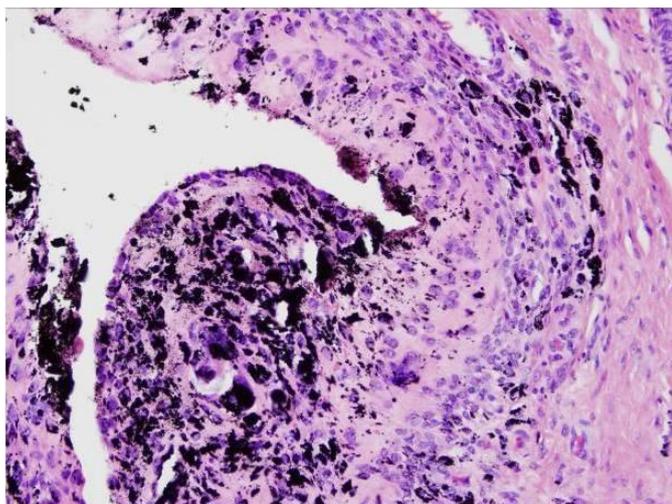
Figure 6: 74 year-old man with periprosthetic metallosis and metal-induced synovitis. Left knee synovium (H&E, 200x magnification). The synovium is reactive and appears loaded with fine black metallic debris.

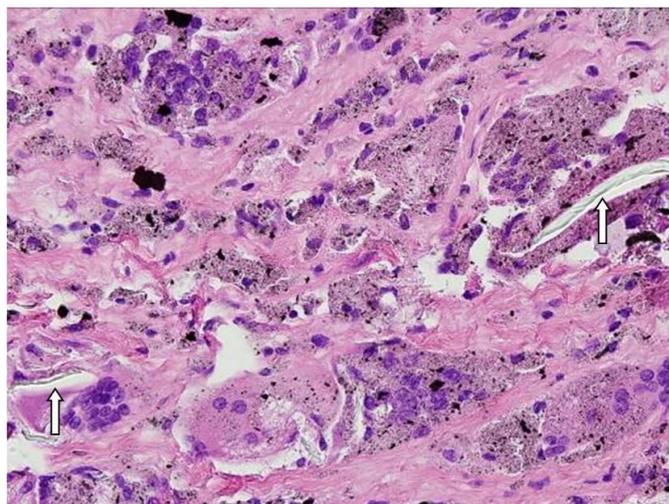
The presence of microscopic debris particles in the soft tissues incites a foreign body inflammatory reaction with a histiocytic infiltrate and multinucleated giant cells (Fig. 7). A fibrotic response ensues in an attempt to encapsulate the immunogen, and the histiocytes that engulf the particles release inflammatory cytokines, such as interleukin-1 [11]. These cytokines may cause the periprosthetic osteolysis (as demonstrated in Figs. 1 and 2) that is associated with implant loosening. Inflammatory cells infiltrate the synovium in response to the debris, which causes synovial hyperplasia and there is histopathologic evidence of black material in the synovium (Fig. 6). This is usually associated with an acutely painful effusion [9]. Metal and polyethylene particles can also be taken up by the lymphatic system and carried away from the joint replacement site [12]. Inguinal lymphadenopathy has been reported due to metallic debris from loosening of a knee prosthesis in a 19 year old patient [12], although this was not present in our case. Elevated metal levels have been found in blood and urine of patients with metallosis [13], but were not evaluated for in our patient.

Figure 7: 74 year-old man with periprosthetic metallosis and metal-induced synovitis. Left knee synovium (H&E, 400x magnification). High power magnification demonstrates the presence of black metallic debris within multinucleated giant cells in the synovial lining. Polyethylene fragments are seen as refractile material within the giant cells (white arrows).
