Clinical Application of Echocardiography in Treatment of One Case of Mechanical Aortic Valve Stenosis with Giant Ventricular Aneurysm

Radiology Case. 2026 March; 20(3):1-8 :: DOI: 10.3941/jrcr.5594

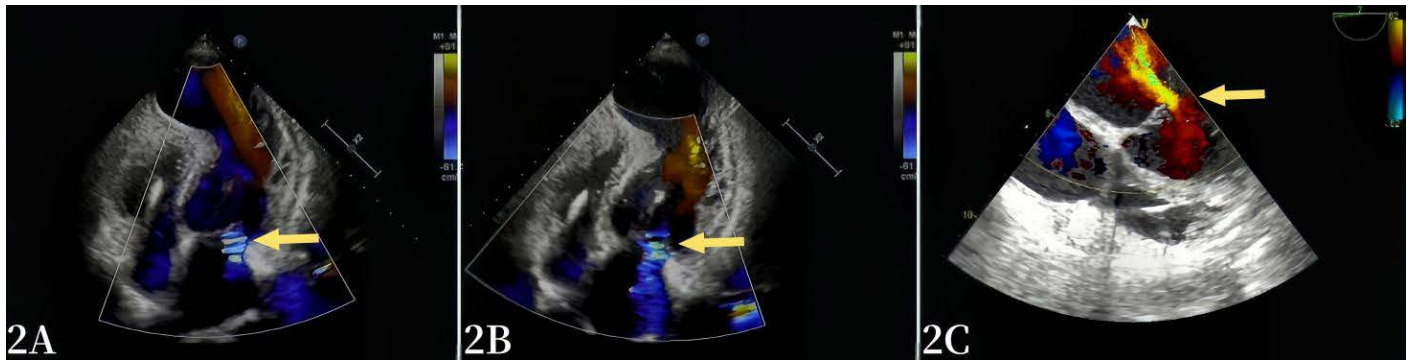
Figure 2: Changes in mitral regurgitation volume. 2A depicts mild MR on a transthoracic four-chamber view in resting state before operation; 2B shows an increase to moderate MR on a transthoracic four-chamber view after squatting test before operation; 2C illustrates severe MR on a transesophageal mid-esophageal four-chamber view after the heart has restarted following the resection of the ventricular aneurysm and secondary aortic valve replacement.

Transthoracic echocardiography (TTE) showed the following features: the left ventricular cavity morphology had changed, appearing like a gourd. The apical myocardium became thin and bulged outward, measuring 5×4 cm, which exercised paradoxically. Multiple strands but no thrombus were visible in the apical aneurysm. The thickness of middle interventricular septum (IVS) was 18 mm, and the thickness of other walls were 9 mm, which contracted normally. The diameter of left ventricular outflow tract (LVOT) was 26 mm, and the flow velocity was 85 cm/s, pressure gradient (PG) was 3 mmHg. There was no systolic anterior motion (SAM), mitral regurgitation (MR) was mild. There were no vegetations on the surface of the mechanical aortic valve, its annulus diameter was only 17 mm, and the diameter of aortic sinus, sinotubular junction, ascending aorta were normal. The peak flow velocity of the prosthetic valves was 380 cm/s, the peak pressure gradient (PPG) was 53 mmHg, the mean pressure gradient (MPG) was 28 mmHg, and the effective orifice area (EOA) was 1.0 cm², the effective orifice area index (EOAI) was 0.62 cm²/m² that calculated by the continuity equation. We measured the left ventricular end-diastolic volume (LV-EDV) was 131 mL, left ventricular end-systolic volume (LV-ESV) was 98 mL, left ventricular stroke volume (LV-SV) was 33 mL, left ventricular ejection fraction (LV-EF) was 25% by Simpson's biplane method. In order to assess the degree of stenosis of prosthetic valves under stress condition, the patient underwent squatting test which was a simple provocation test. After squatting test, the peak flow velocity of the mechanical aortic valve increased to 440 cm/s, PPG increased to 74 mmHg, MPG increased to 41 mmHg, and MR increased to moderate. TTE preliminary diagnosed that severe prosthetic-patient mismatch (PPM) of the mechanical aortic valve orifice, a giant apical aneurysm, hypertrophy of the middle IVS, secondary MR, and left ventricular systolic function reduced significantly (Figures 1,2).

The function of MV depends on a balance between normal left ventricular wall contraction and traction to maintain the structural integrity of the MV. In this case, the MR in the preoperative resting state was mild, which was secondary to left ventricular systolic dysfunction. The level of regurgitation increased to moderate after squatting test. The reason for the increase in regurgitation is that the myocardium contracts excessively in order to adapt to the increased oxygen consumption of the myocardium, but at the same time, the myocardial traction on the valve leaflets also increases excessively [12]. After the ventricular aneurysm was resected, TEE showed a significant increase in MR. We considered that the original middle of the left ventricle became the reshaped apex after left ventricle was reshaped, the papillary muscle was now attached to apex, which was equivalent to downward movement of the papillary muscle. Excessive stretching of the valve by the systolic papillary muscles resulted in increased MR. So we opened cardiopulmonary bypass again, and performed MV replacement decisively.

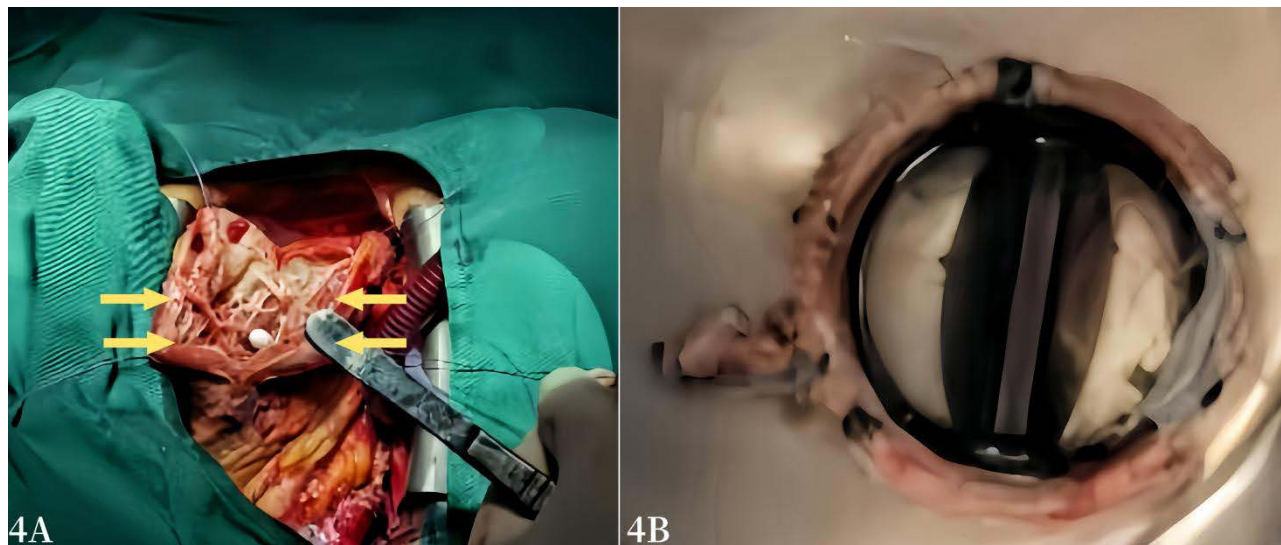
Figure 4: Intraoperative gross findings. 4A shows a giant ventricular aneurysm with many strands; 4B shows the original artificial mechanical aortic valve with a smooth surface and no vegetations.

We performed a secondary thoracotomy surgery for her, including secondary replacement of mechanical aortic valve, enlargement of aortic valve annulus, resection of apical aneurysm, left ventricular radiofrequency ablation, with preparation for resection of IVS and MV replacement. On operation, there was an apical aneurysm, measuring 4×6 cm. Therefore, we resected the apical aneurysm, performed an apical plasty, and performed cryoablation of the anterior and posterior papillary muscle roots under direct visualization. We incised the aorta and peeled off the original mechanical aortic valve, which

had no vegetations on its surface. Then we enlarged the aortic valve annulus and replaced the valve with a Medtronic 505DA20 mechanical valve (EOA, 1.7 cm²; EOAI, 1.05 cm²/m² in this case). We observed the structure and hemodynamic changes of the heart by transesophageal echocardiography (TEE) after cardiopulmonary bypass was removed, while the patient's heart resumed sinus rhythm at 40 bpm and BP 90/50 mmHg. We detected that the new mechanical aortic valve was opening well with MPG was 9 mmHg, without regurgitation and perivalvular leakage. LVOT-PG was 5 mmHg, and the left ventricular cavity morphology was in good shape, appearing like a cone, and all ventricular walls exercising actively. But MR increased to severe degree (Figures 3,4), so we restarted the bypass machine and replaced MV with Medtronic 26 mechanical valve. Finally, the surgery was completed successfully.
